Kitchener Rock Walk 2016

Start at the Kitchener Public Library at Queen Street entrance.

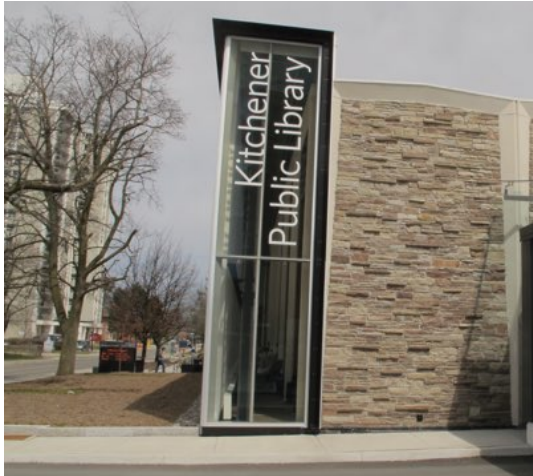
Kitchener Public Library

The interior of the library has Eramosa Dolostone floors and around the elevators. This is local dolostone from the Warton area. It is thinly bedded and polishes well.

Outside the library along Queen Street you will see a wall of natural sandstone with tones from cream to dark brown. The colour is from its iron content. I'm not sure where this sandstone is from, it makes a rather interesting effect with the concrete panels along the side of the building. Polished black anorthosite "black granite" is used along the Queen Street side and as a hammered finish on benches.

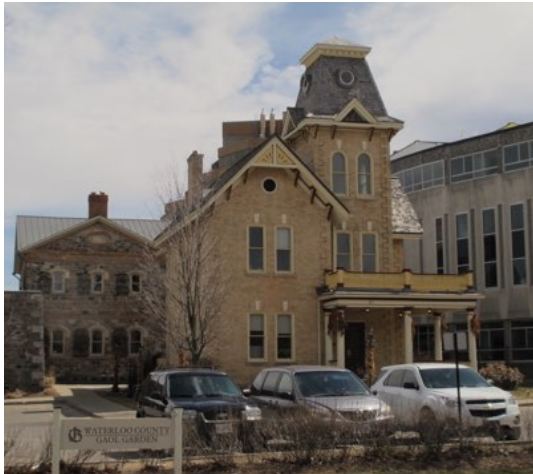
Gaol House, Governor's Residence

This building was originally the governor's residence of the gaol. It is located behind the Court House and it is made of yellow brick. The bricks are yellow because they were made from local glacial till and the glacial clay in this area has a lot of calcium in it.

A number of years ago the bricks were painted red. The bricks have been cleaned to their original yellow colour. The yellow bricks are softer than the red bricks which are used around Kitchener/ Waterloo and other parts of Southern Ontario.

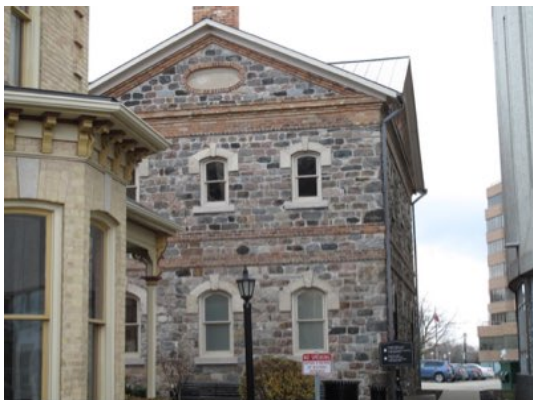
Behind the Governor's house is the Gaol made of field stone. If you look closely at the walls you can see that it is built of different kinds of rocks. You can find granite, gneiss and various other rocks.

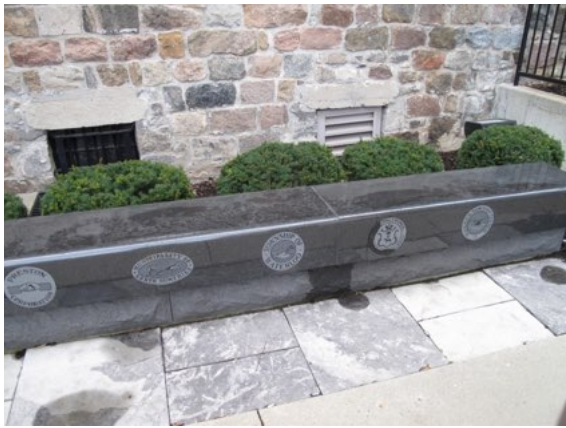
Black anorthosite “black granite” polished bench celebrating the townships which make up Waterloo County.

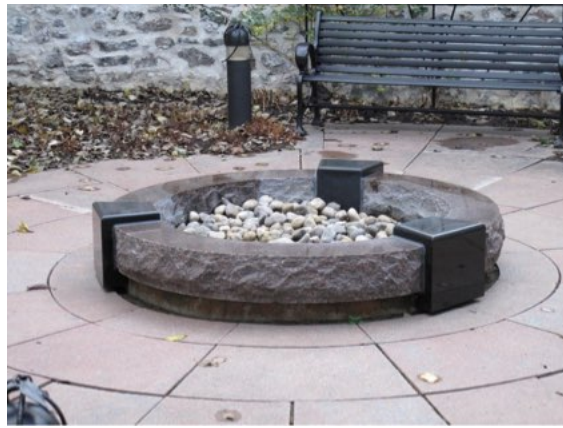
Waterloo County Gaol House Garden. In the middle is a feature filled with river rock of granite and an anorthosite.

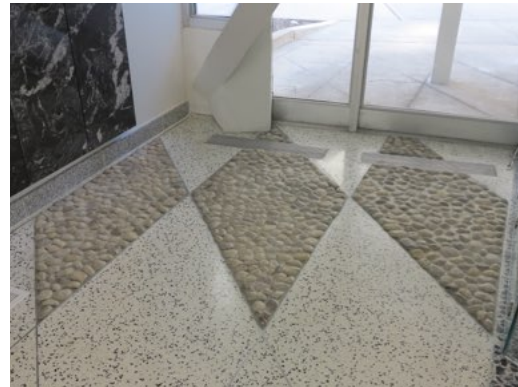
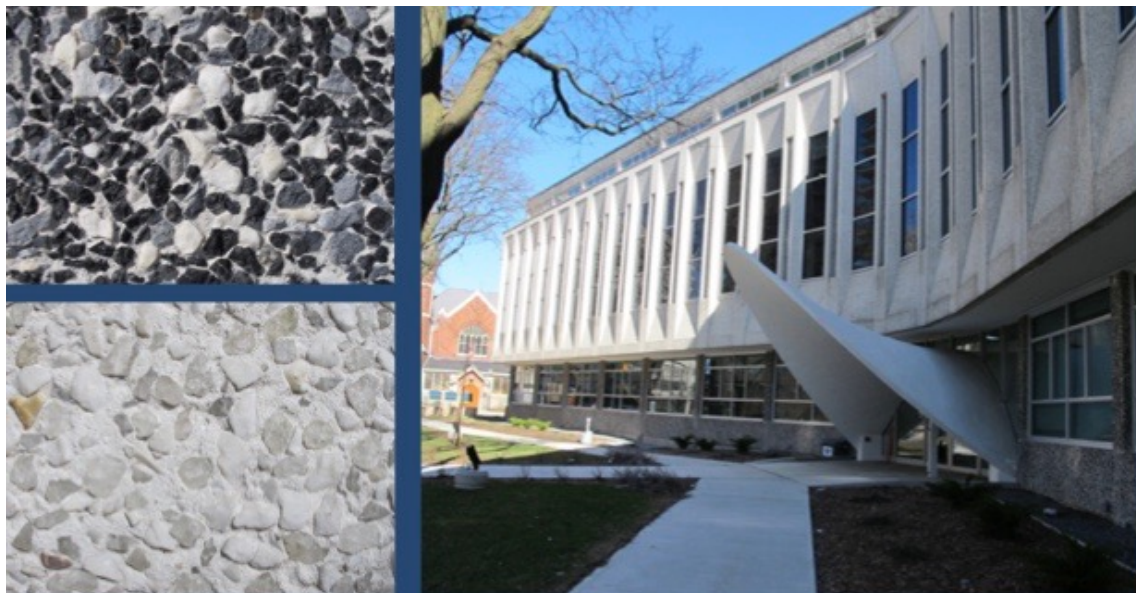
The Old Courthouse Building, Weber Street.

The courthouse has two textures of rock chips decorating the outside wall. The white wall is quartz and marble chips and the grey wall at the bottom is grey gneiss, white quartz and a black metamorphic rock. Terrazzo flooring is beautiful in this building. To make this kind of flooring they took white and black chips of marble, mixed it with concrete and then smoothed and polished the surface. Pebbles add interest near the entrance.

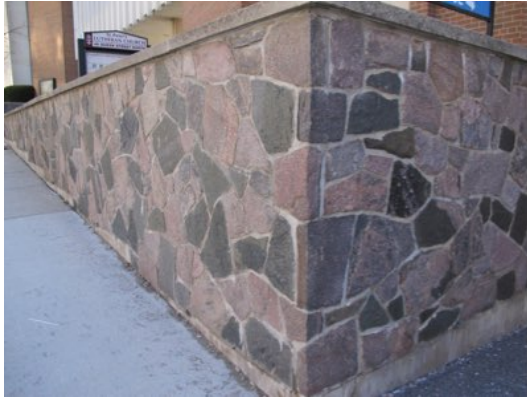
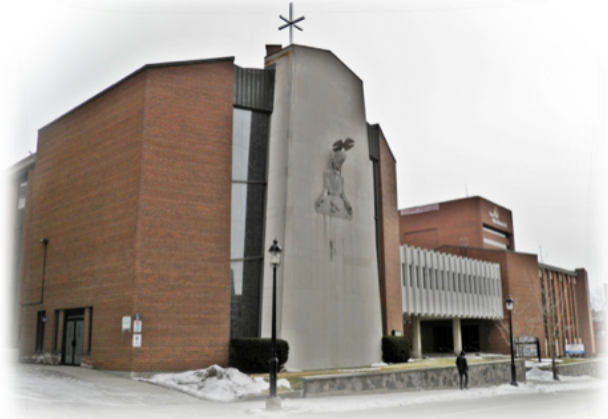
St. Peter's Lutheran Church

At the base of the Church we can see different kinds of metamorphic rock called gneiss. The rock has a natural fracture in it that allows it to break into thin sheets of decorative stone. There are various colours: the red rocks are mainly feldspar and the black is mainly biotite mica. Occasionally, you may also find red garnets in this rock. If you look closely and have a bit of luck you may find some!

Look up at the side of the church. As you can see in the photo, there is St. Peter carved out of limestone. If you look just below his hand on the right hand side, you will see a squiggly line which has weathered out. There is another one across the goblet. These lines are called stylolites. They wiggle up and down and were formed from chemical dissolution, a process that reduces the volume of the rock. Soluble clay may fill the serrated surface. Stylolites are common in limestone.

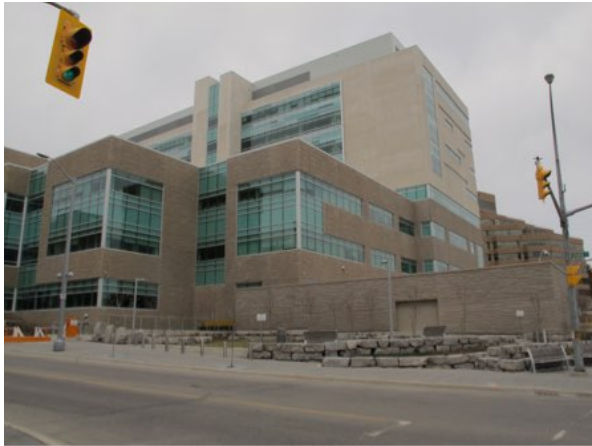
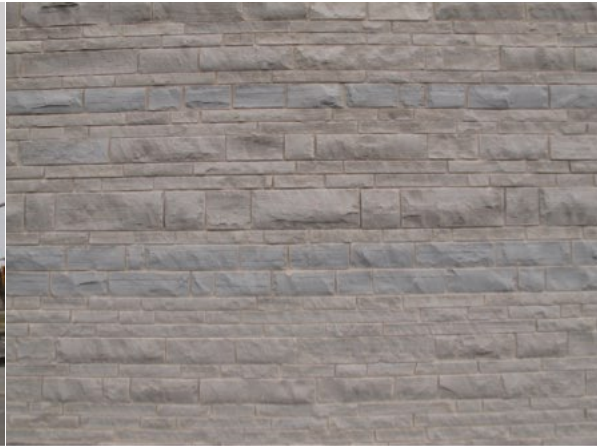
Waterloo Regional Courthouse

Some walls are decorative concrete; others are grey and beige Silurian Eramosa Dolostone from Warton, Ontario. Look closely at the thin layers of lime mud which were deposited in tropical seas 443 - 419 million years ago. Giant scorpions lived in the shallow sea. Blocks of porcelaneous limestone of the Ordovician Lindsay Formation (485.4 and 443.8 million years ago) are used in the gardens around the building. Look closely at the fine-grained smooth surface and the stylolites on some of the weathered surfaces of the rocks.

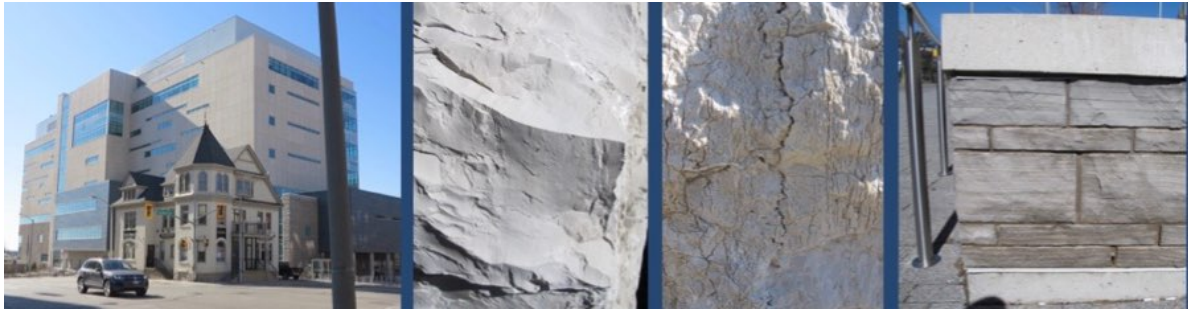
The Immigration Canada Building is clad with grey granite at the bottom and Indiana limestone of Mississippian age (360-320 million years old) which is found between Bloomington and Bedford, Indiana. Rail transportation allowed the rock to be used all over North America. If you look just to the left of the door you will see squiggly lines in the rock below the window. On the right hand side of the door you are able to see corals in the rock. You can see them vertically from the top and as cross sections. You will also see bryozoans, which look like little twigs on the surface. Around the doorway they've added some brownish looking limestone to make a colour effect. It's coarser material with broken up crinoids and shell fragments in it (it is a beach deposit). Look down and you will see that the granite and the limestone are becoming weathered by the salt that is put down in the winter time.

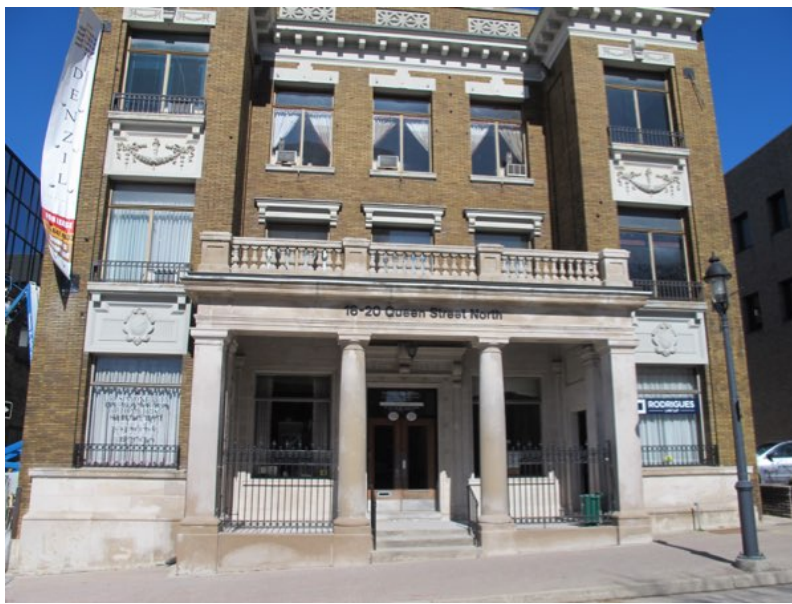
16-20 Queen Street North

Sandstone columns and elegantly carved doorway. Sandstone resists salt damage.

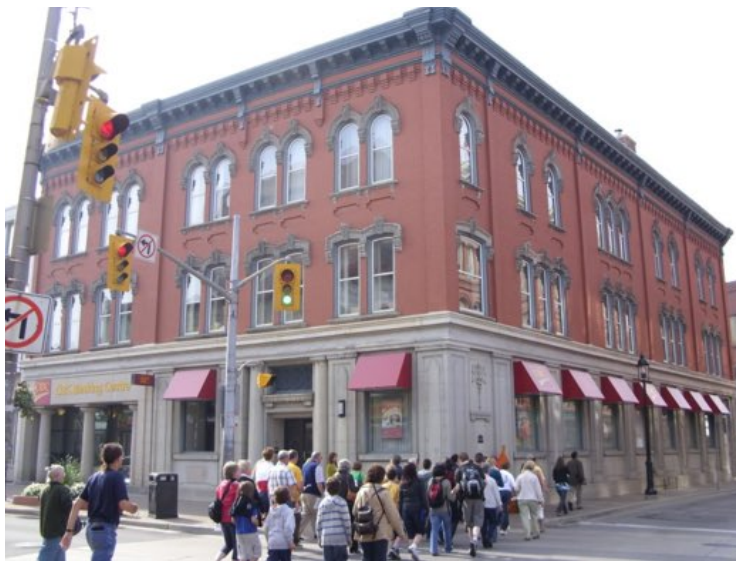
CIBC Bank on the corner of King and Queen.

The exterior walls are moulded concrete. Look closely and you will see angular fragments of limestone. Inside the CIBC building the floor is terrazzo. We also have some granite near the door. There are a few spots where you can see extra large crystals of feldspar and other dark minerals in the rock.

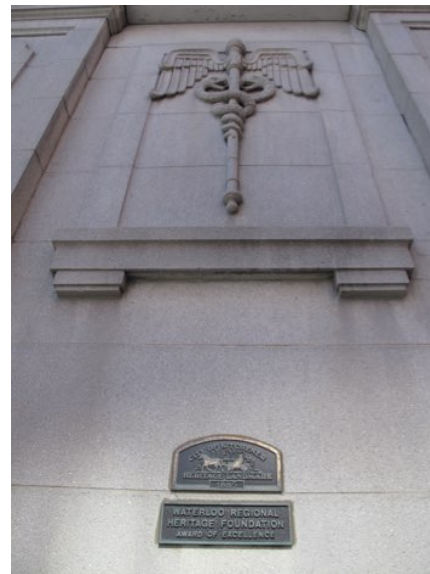
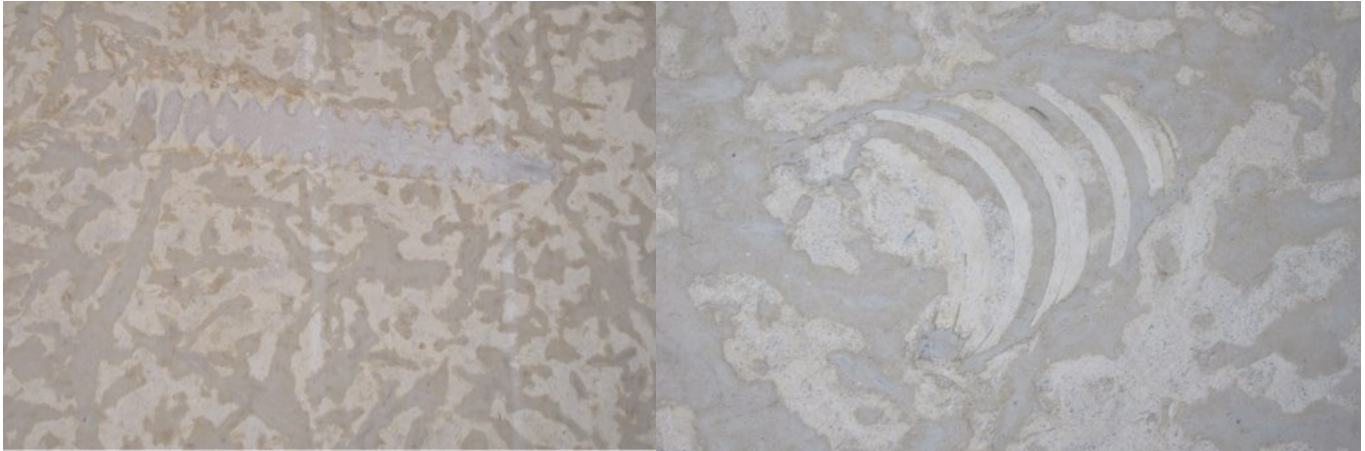
At the Centre for Mental Health, the Benton Building, view the Tyndall Stone, a dolostone from the Ordovician Red River formation, Garson, Manitoba. Both ends of the Benton Building are covered with this stone. It is used as the decorative stone in the interior of the parliament buildings in Ottawa. Tyndall stone is also known as tapestry stone; the pattern formed by shrimps that lived in small tunnels in the lime mud seabed, altering the chemistry of the material and making this pretty pattern in the rock.

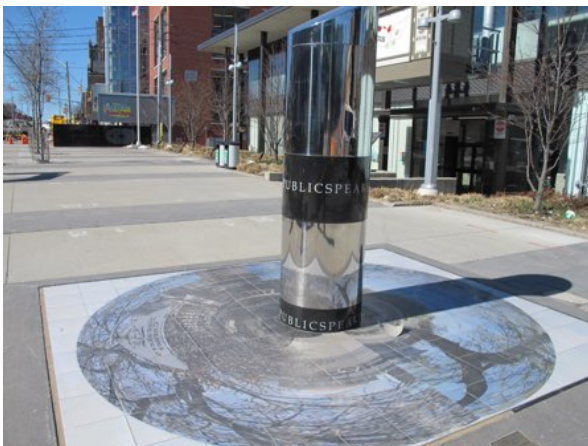
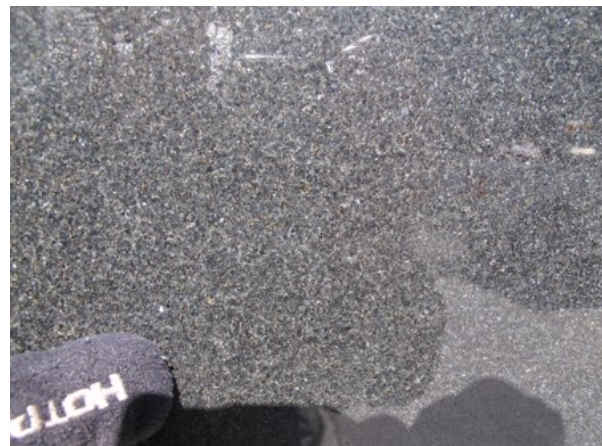
Speaker's Corner

The black polished rock here and used to make seats along King Street is a fine grained black rock. Volcanoes erupting this rock are found on Hawaii.

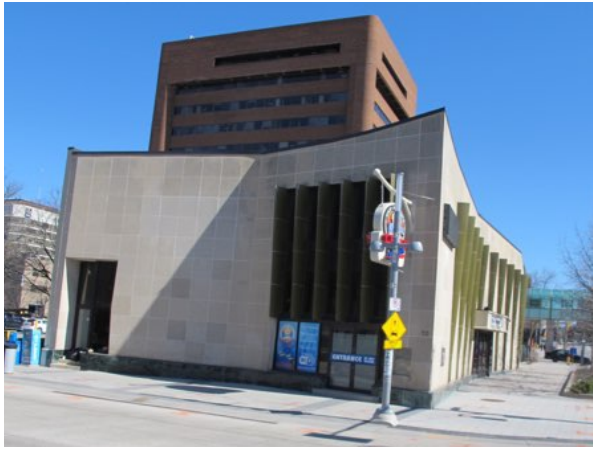
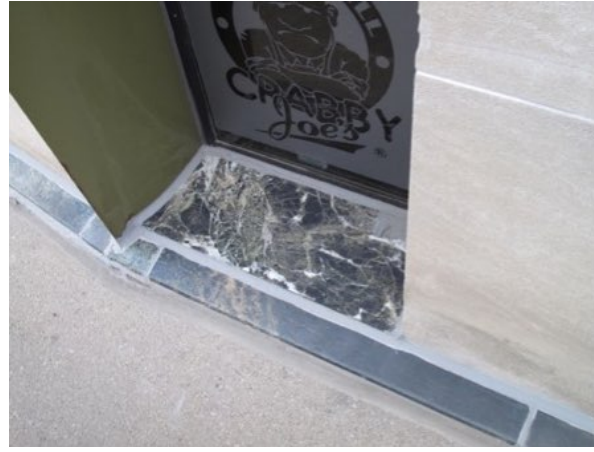
Crabby Joes at the corner of Fredrick and King Street.

You may notice that we're once again looking at Indiana limestone. This building has been around long enough for the fossils to start to weather out. Look down in between the windows and the rock below the limestone is serpentine. Serpentine is metamorphosed peridotite which has turned into a beautiful decorative stone with green olivine and white calcite. Oceanic crust and uppermost mantle from ocean basins containing ultramafic rocks have abundant **serpentine**. The rocks near Asbestos, Quebec are formed in this way and also have asbestos in them. This decorative stone is not hazardous!

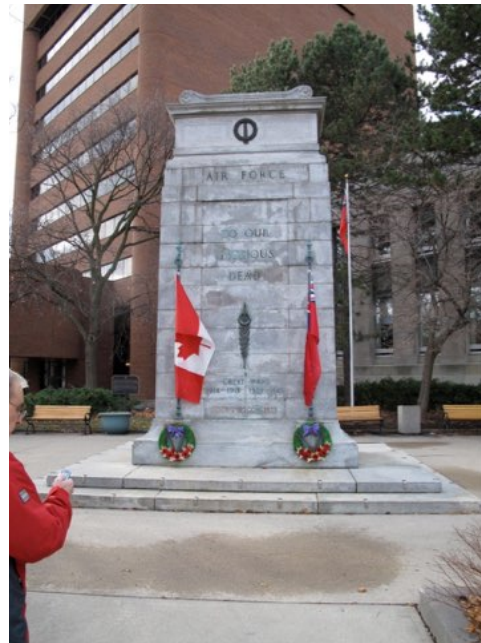
Kitchener Cenotaph, Frederick Street.

This rock is a granite. It looks like *Rock of Age's Granite* from Vermont. Similar granite is from nearby Stanstead, Quebec. If you look closely in some places you may notice inclusions in the rock which are weathering a little bit faster than other sections. The inclusions may appear slightly brownish. Also notice that the lettering, which is bronze, weathers and forms a green copper stain on the surface.

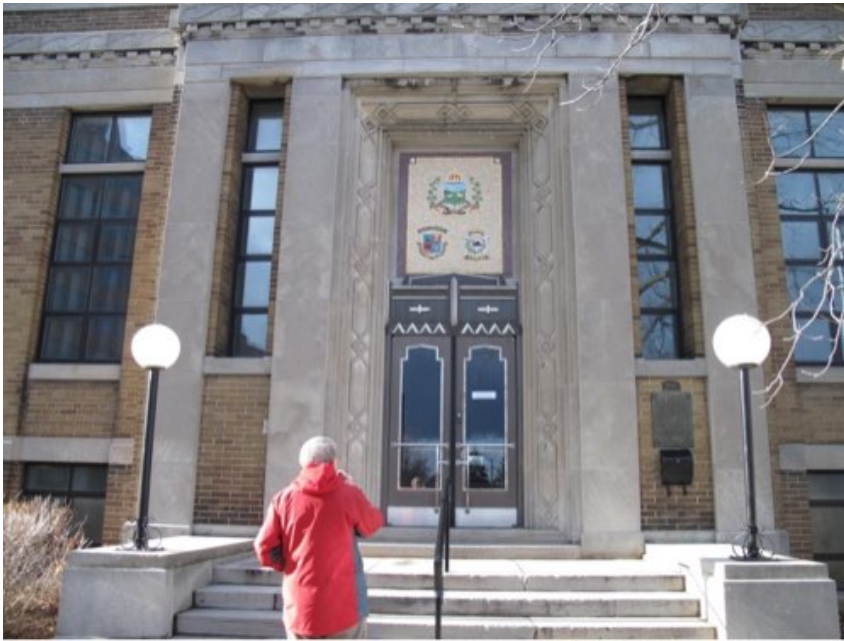
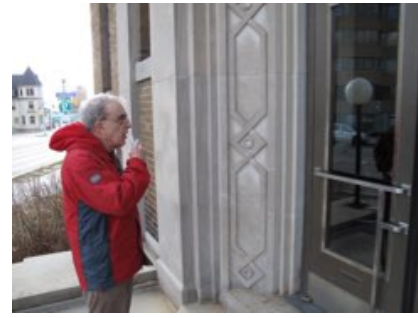
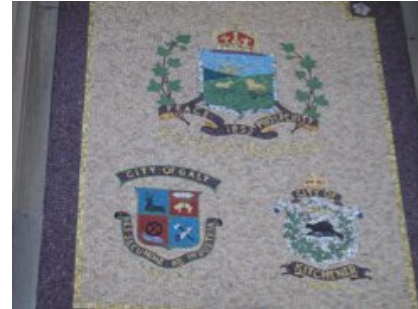
The Registry theatre is just east the intersection of Weber on Frederick Street.

Have a look around the front door. You will find it's made out of Indiana Limestone, of Mississippian age (358.9 to 323.2 million years ago). If you look closely at the stone around the door you will see fossils in the rock as well as where rain and chemical weathering occur (from sprinkling salt in the wintertime). If you look at the rock from its side you can see the weathering goes straight up and down showing the original bedding in the rock. If you ever get the chance to visit inside the building, there is beautiful terrazzo work with marble on the steps.

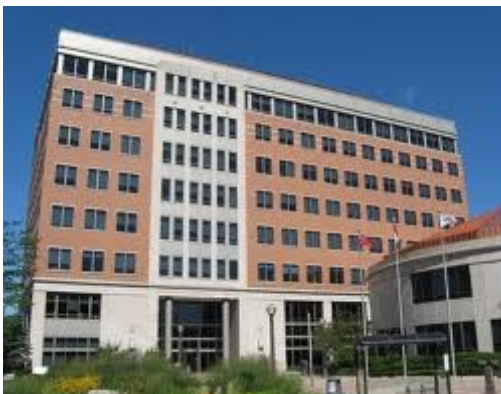
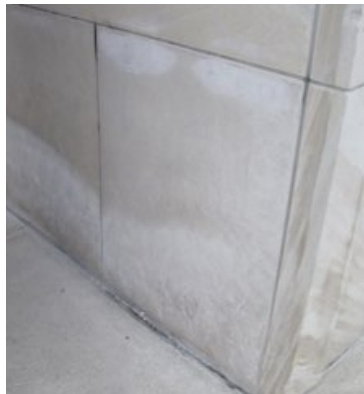
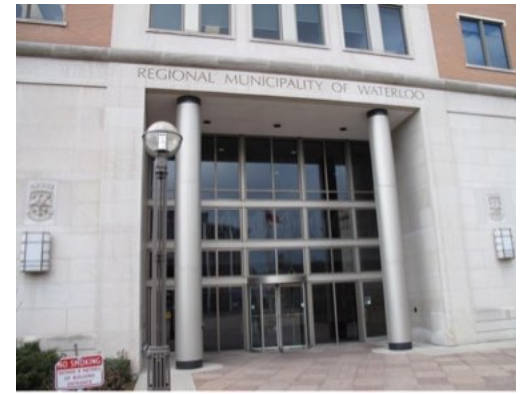
Regional Municipality of Waterloo Building

In front of the building you will see glacial erratics in the rock garden. Check out the different kinds of gneisses, granites, and other rocks in the decorative garden. Look down as you're walking and see the concrete and granite tiles (the pink) in front of the main entrance. Look up and all around the main door and you'll see some of these patterns are the shape of channels in the lime mud as this deposit formed. Salt damage is at the front door. Enter the building and enjoy the polished marble.

At the rear of the building as you return to the Library, note more salt damage!
