## Laboratory Lessons Learned

### Incident Overview:

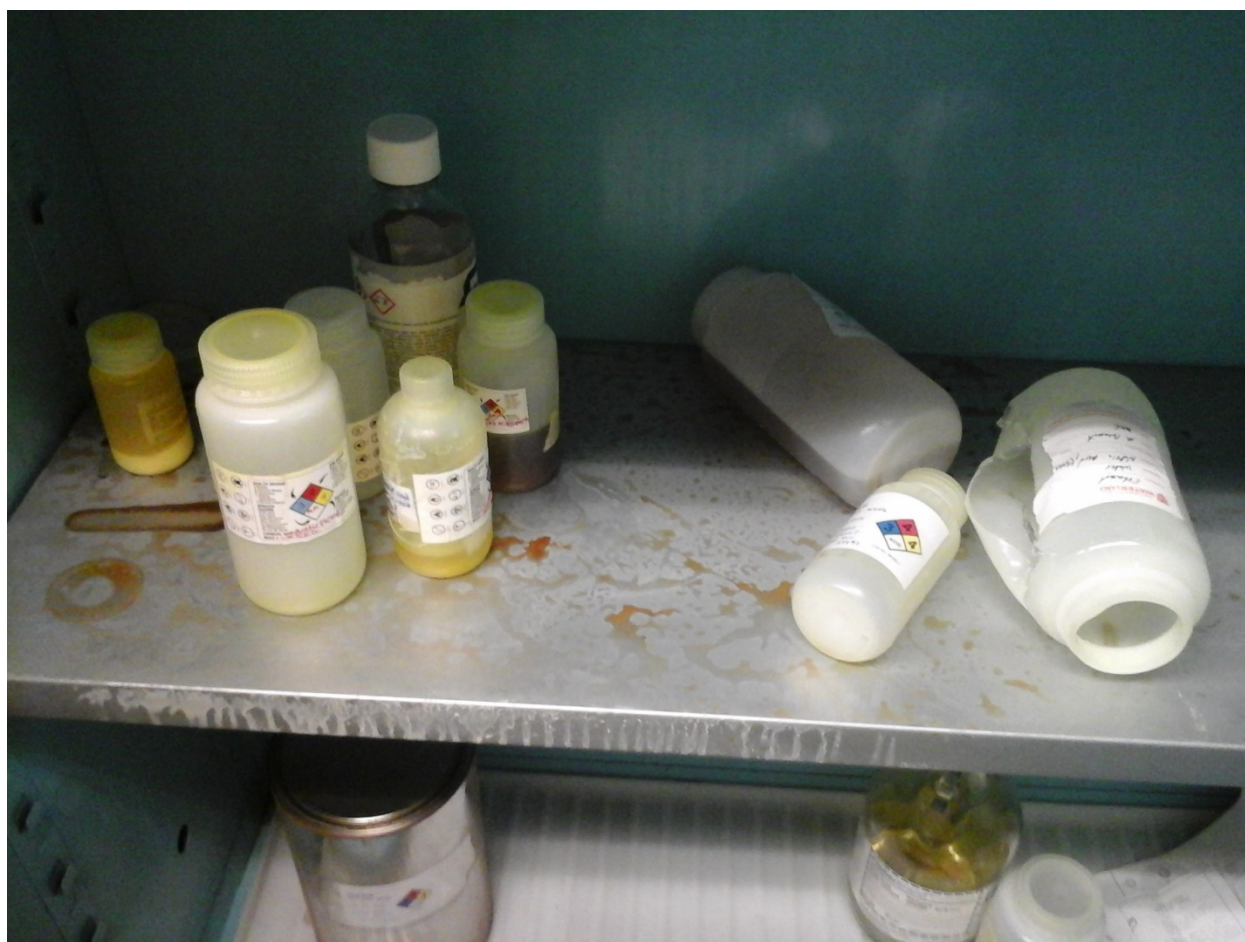
At the end of the day, the individual had approximately 200 mL of waste Nital. They deposited this leftover Nital in a waste container (Nalgene) that contained between 100 to 200 mL of a solution containing 50% nitric acid and 50% water. The container had been labelled with this mixture. The container was sealed and left in a storage cabinet overnight. The next day, the bottle of Nalgene was discovered ripped open (as if from an explosion) and the contents were strewn about the cabinet.

Figure 1: Image showing the destroyed waste bottle.

By mixing Nital with the material in the waste container (nitric acid and water), the ratio of nitric acid to alcohol in the resulting mixture became dangerously high. This resulted in a reaction that likely resulted in the rapid production of some toxic nitrogen oxides.

- Updated the SOP to reflect current usage controls and disposal practices for Nital
- Required students to complete a risk assessment before beginning new research projects – which is reviewed by her: [General Laboratory Process Risk Assessment](#)
- SOPs for dangerous chemicals or processes must be signed off by students before being allowed to use those chemicals or perform those processes.
- Completed an orientation on proper waste disposal with all students
