Effects of Heat Treatment on Grain-Boundary β -Mg₁₇Al₁₂ and Fracture Properties of Resistance Spot-Welded AZ80 Mg Alloy

The distribution and morphology of β -Mg₁₇Al₁₂ intermetallic phase in resistance spot-welded AZ80 Mg alloy were investigated by means of optical microscopy, scanning electron microscopy, and X-ray diffraction. The influence of intermetallic phase on mechanical strength was studied by tensile shear testing and fractography. The results showed that continuous networks of β -Mg₁₇Al₁₂ formed along grain boundaries in both the nugget and heat-affected zone of the spot-welded AZ80 Mg alloy. Those continuous grain-boundary β -Mg₁₇Al₁₂ networks acted as effective crack propagation paths, which had negative effects on the weld strength. Post-weld solution heat treatment effectively reduced the amount of β -Mg₁₇Al₁₂ and broke the grain-boundary intermetallic networks in both the nugget and heat-affected zone. This significantly increased the weld strength of AZ80 Mg alloy and changed the fracture mode from nugget pull-out in the as-welded condition to through-thickness after heat treatment.

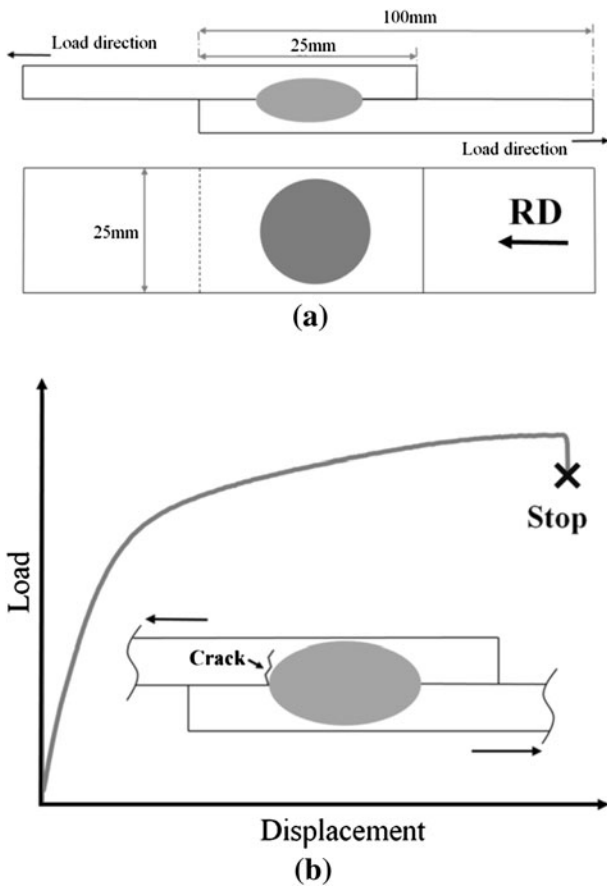
Fig. 1—(a) Scheme of RSW specimens. (b) Scheme of the tensile shear test procedure for assessment of the crack location.

The material used in the current study was 2-mm-thick commercial-grade hot-rolled sheets of AZ80 (7.7 wt pct Al, 0.7 wt pct Zn, 0.2 wt pct Mn). Rectangular specimens of 100 mm × 25 mm were prepared with the rolling direction (RD) aligned along the longer side according to AWS-D17.2 (see Figure 1(a)). The surfaces of the sheets were chemically cleaned, using a solution of 2.5 g chromic oxide and 100 mL distilled water before welding. Resistance spot welding was performed using a mid-frequency DC resistance spot-welding machine. The optimized welding parameters 26 kA welding current, 8 cycles welding time, and 4 kN welding force were selected based on the maximum strength of the weld nugget and prevention of expulsion during the welding process.^[5] Post-weld heat treatment was performed above the solvus temperature of Mg-8 wt pct Al alloy

To further study the effects of heat treatment on the failure mode and the crack propagation path of AZ80, peak-hold tensile tests as illustrated in Figure 1(b) were conducted. Figure 7(a) shows the typical crack propagation path of an as-welded sample. The crack first initiated from the sharp slit between the two overlapping sheets, then propagated along the fusion line and finally transversed through the HAZ and base metal (see Figure 7(a)). The SEM image of Figure 7(b) shows that the crack path is along the GBs decorated with β -Mg₁₇Al₁₂ intermetallic. As indicated by the black and white arrows in Figures 7(c) and (d), secondary microcracks close to the primary crack region were also observed. The black arrows point to microcracks which occurred inside or traversed through the β -Mg₁₇Al₁₂ intermetallic, while the white arrows point to microcracks at the β -Mg₁₇Al₁₂/ α -Mg interface.

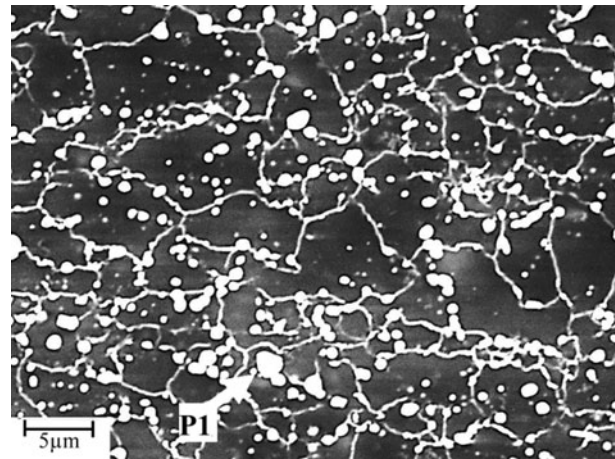
Fig. 2—SEM microstructure of the as-received AZ80 alloy base metal; the EDS analysis results for the highlighted particle are shown in Table I.

The base metal microstructure of the AZ80 Mg alloy is shown in Figure 2. Fine spherical particles (white) were distributed both within the grains and along the GBs, which according to the EDS results were enriched with Al and identified as β -Mg₁₇Al₁₂ phase (see composition of P1 in Table I). Apparently, the eutectic β -Mg₁₇Al₁₂ precipitates were formed during the sheet metal casting and hot-rolling processes because of the presence of Al in excess of its solid solubility limits in the α -Mg matrix.^[18]

During the resistance spot welding, the HAZ of the AZ80 spot weld was quickly heated up to greater than the solvus temperature because of the fast heating rate. However, the pre-existing β -Mg₁₇Al₁₂ particles at the GBs of the base metal (Figure 2) did not have enough time to dissolve into the α -Mg matrix since their dissolution is controlled by the time-temperature-dependent solid-state diffusion mechanism. On further heating the material in HAZ up to the eutectic temperature (T_E), the remaining β -Mg₁₇Al₁₂ reacted with the surrounding α -Mg matrix and formed the eutectic (C_E) liquid film at the GBs (Figure 3(d)). This is also known as GB liquation, a phenomenon that has been observed previously in the HAZ of Al alloys.^[19,20] During cooling, the liquid at the GBs formed a continuous network of β -Mg₁₇Al₁₂ phase by eutectic reaction.

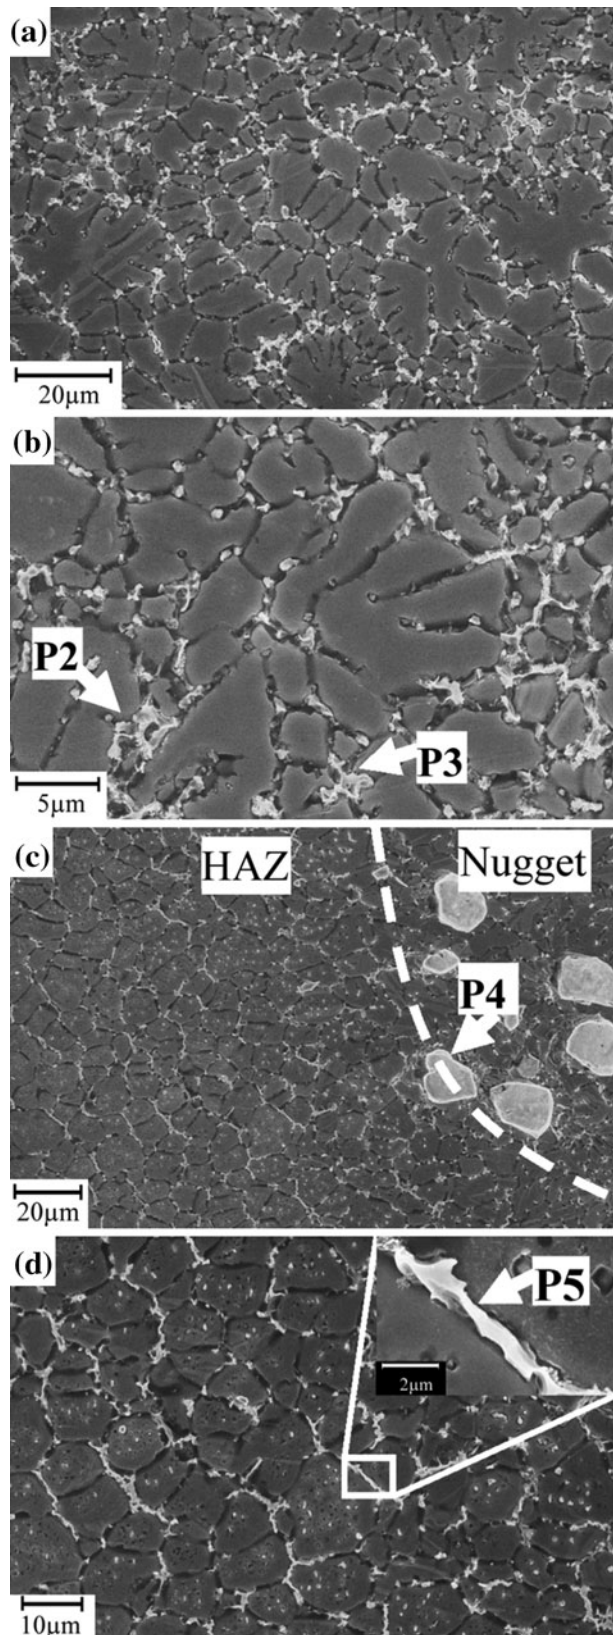
Fig. 3—Typical SEM images of the as-welded microstructure: (a) Microstructure of the fusion zone. (b) High-magnification image from the interdentritic regions. (c) Microstructure of HAZ. (d) Grain boundary particles in HAZ; the EDS analysis results for the highlighted particles are shown in Table I.

Figures 3(a) and (b) shows the typical microstructure of the fusion zone (nugget). In the as-welded condition, the β -Mg₁₇Al₁₂ particles (the white phase in Figure 3(b)) were observed to be mainly distributed along the interdendritic regions in the form of continuous networks. During solidification, the β -Mg₁₇Al₁₂ phase was formed because of the eutectic reaction.

Figures 3(c) and (d) illustrate the microstructure of the HAZ. The large particles observed at the fusion boundary (P4 in Figure 3(c)) were enriched in Al and Mn (Table I) and identified as Al₈Mn₅. Such particles have been characterized and reported in a previous study on resistance spot weld of AZ31 alloy.^[5] In the HAZ, the distribution and morphology of β -Mg₁₇Al₁₂ phase were changed from evenly distributed fine spherical particles in the base metal to continuous networks along the GBs (see P5 in Figure 3(d)). The composition of all the highlighted particles in Figure 3 was analyzed using EDS, and the results are listed in Table I.

Previous studies have shown that the formation of β -Mg₁₇Al₁₂ as continuous networks along the GBs or interdendritic region decreases the toughness and ductility of the as-cast structures.^[11,15] As discussed earlier, in AZ80 spot welds, continuous networks of β -Mg₁₇Al₁₂ phase formed along the GBs of the HAZ. These continuous GB β -Mg₁₇Al₁₂ networks created a preferred path for propagation of the pre-existing crack during the tensile shear test. On the other hand, the interdendritic β -Mg₁₇Al₁₂ network inside the fusion zone (Figures 3(a) and (b)) was considered to be a tortuous crack path because of the dendritic nature of this area, which offered more resistance to crack propagation. Also, cracks could grow more easily through the brittle intermetallic-bearing GBs of large grains in the HAZ (Figure 3(d)).

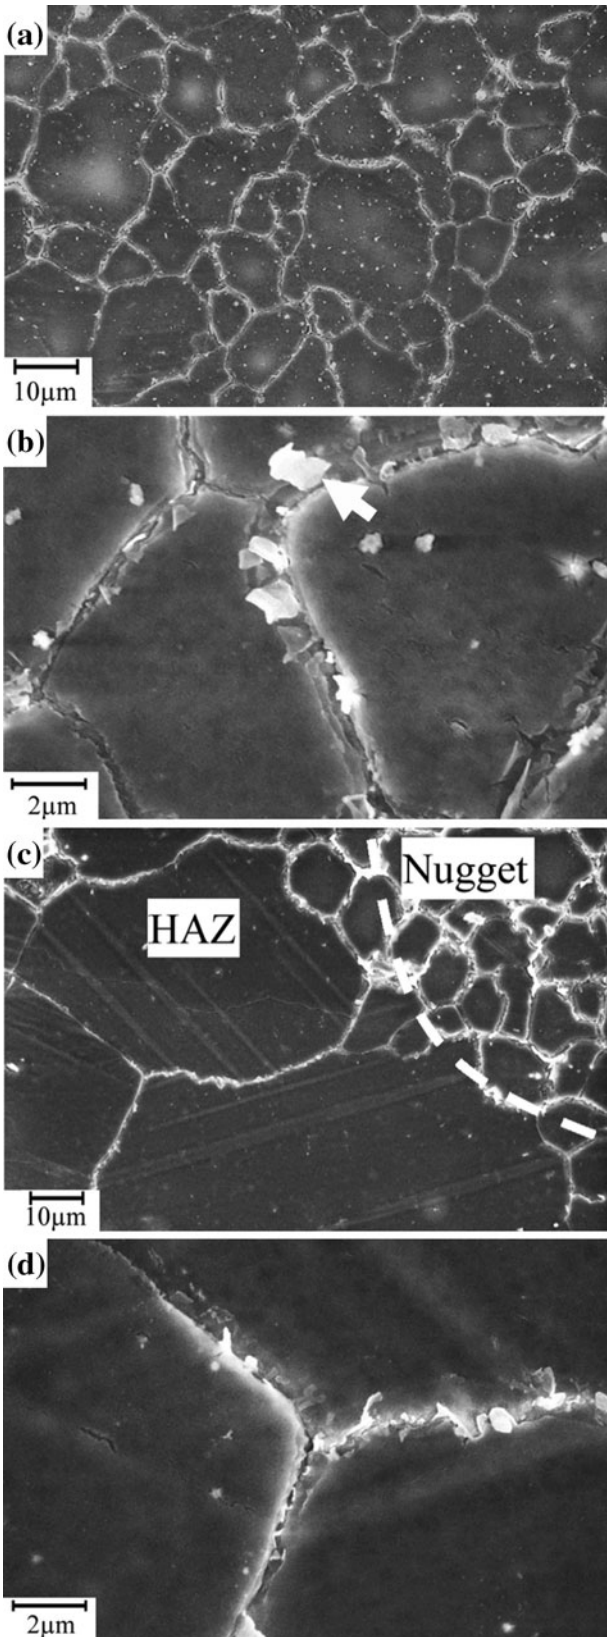
Fig. 4—Typical SEM images of the post-weld heat-treated microstructures: (a) SEM microstructure of fusion zone. (b) Grain boundary particles in fusion zone. (c) SEM microstructure of HAZ. (d) Grain boundary particles in HAZ.

As illustrated by the SEM images of Figure 4, the selected heat treatment partially dissolved the interdendritic β -Mg₁₇Al₁₂ phase into the α -Mg matrix in both the HAZ and weld nugget. In the HAZ, the continuous networks of β -Mg₁₇Al₁₂ at the GBs were disrupted and changed to irregular shaped β -Mg₁₇Al₁₂ (see Figure 4(d)). The average grain in the HAZ of the as-welded samples obtained by the linear intercept method was measured to be 9.2 μ m. However, the HAZ average grain size increased to 78.8 μ m in the heat-treated samples. In both HAZ and nugget, the sub-micron-sized particles were clearly visible inside the grains. These intragranular particles are believed to be the those pre-existing in the as-welded condition, which did not dissolve into the α -Mg matrix.

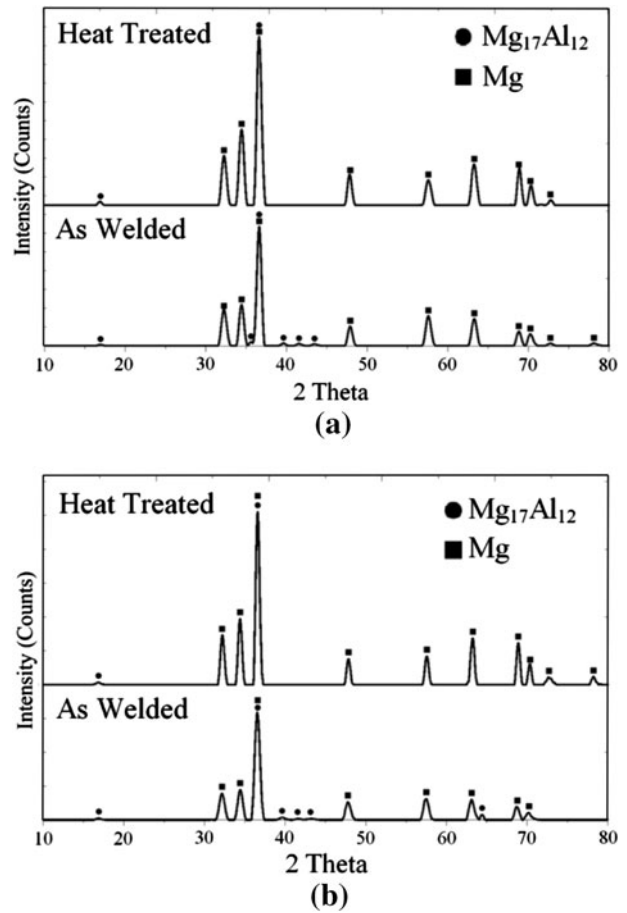
Fig. 5—XRD spectra from (a) Fusion zone. (b) Heat-affected zone.

X-ray diffraction (XRD) spectra in Figure 5 further confirmed the effect of heat treatment on the dissolution of β -Mg₁₇Al₁₂. The XRD results showed the presence of β -Mg₁₇Al₁₂ intermetallic compound in both the fusion zone and the HAZ. After heat treatment, the β -Mg₁₇Al₁₂ peak intensity of both the fusion zone and the HAZ almost disappeared.

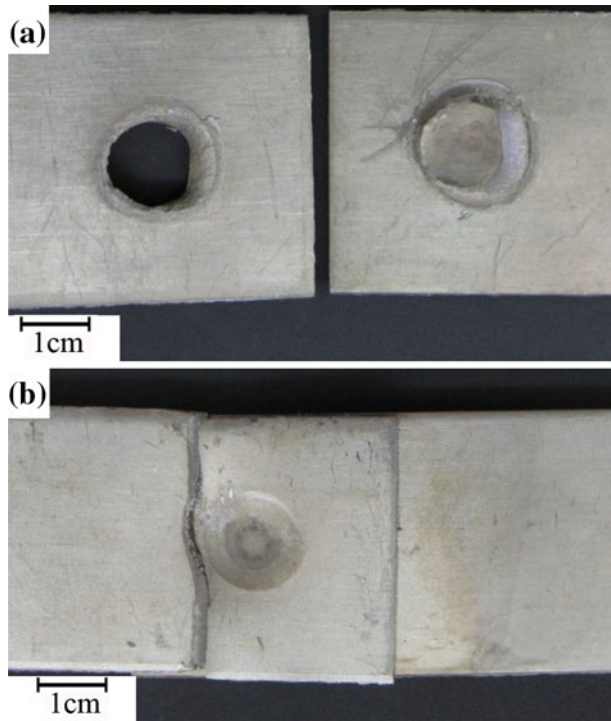
Fig. 6—Illustration of fracture modes: (a) Nugget-pullout fracture for the as-welded sample. (b) Through-thickness fracture after the post-weld heat treatment.

Table II lists the tensile shear strengths and the fracture modes of the weld nugget in the as-welded and the heat-treated conditions. The strength of the as-welded AZ80 was lower than that of the post-weld heat-treated AZ80. The selected heat treatment increased the strength of the welds by 34 pct. The fracture mode of the AZ80 weld also changed from the nugget pullout of Figure 6(a) to through-thickness failure of Figure 6(b) after the post-weld heat treatment.

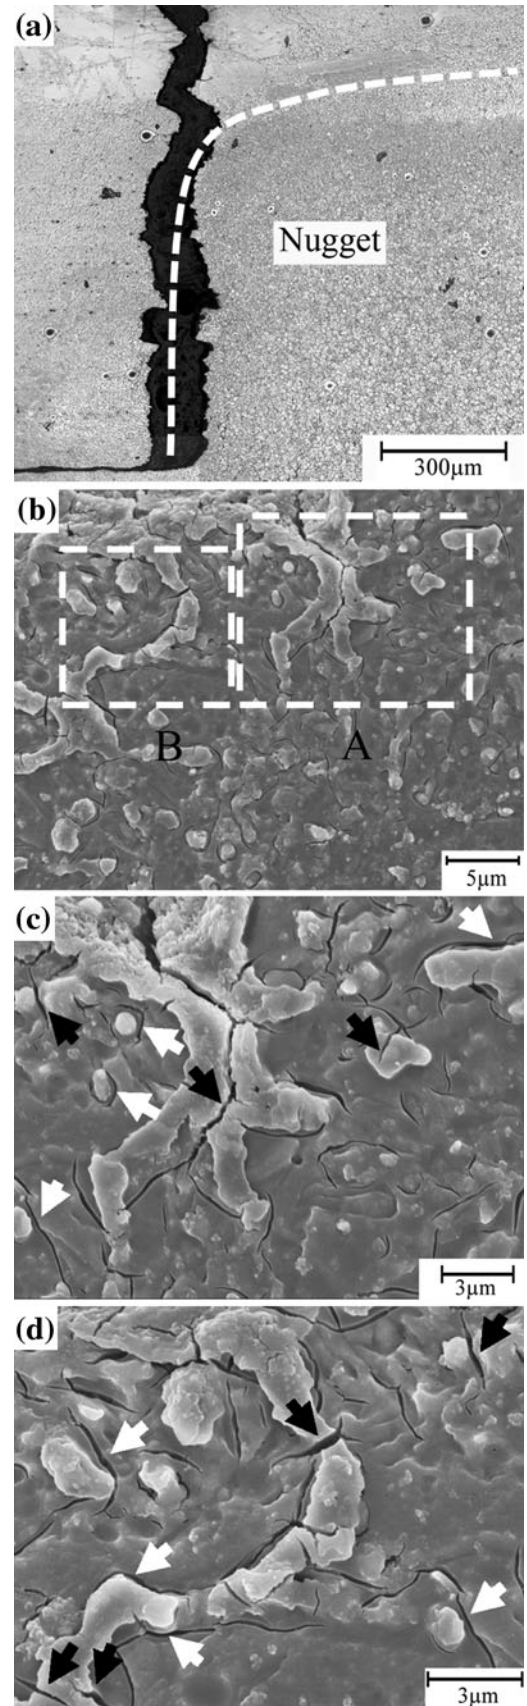
Fig. 7—(a) Typical crack propagation path in the as-welded condition. (b) Microstructure near the crack region for the as-welded sample. (c) Area A at higher magnification. (d) Area B at higher magnification.

In terms of the as-welded microstructure near the crack region (see Figures 7(c) and (d)), the crack could easily propagate by coalescing microvoids/cracks, which were formed by two distinctive mechanisms:

As indicated by black arrows in Figures 7(c) and (d), the intermetallics were ideal sites for crack initiation and propagation. When the Mg-Al intermetallic compound grew too thick, it became significantly brittle. A similar phenomenon has previously been observed in Mg-to-Al dissimilar welds.^[24,25] The presence of a hard brittle second phase in the GBs of soft solute-depleted matrix was reported to deteriorate the mechanical properties in HAZ.^[10] Under tensile loading, the depleted matrix

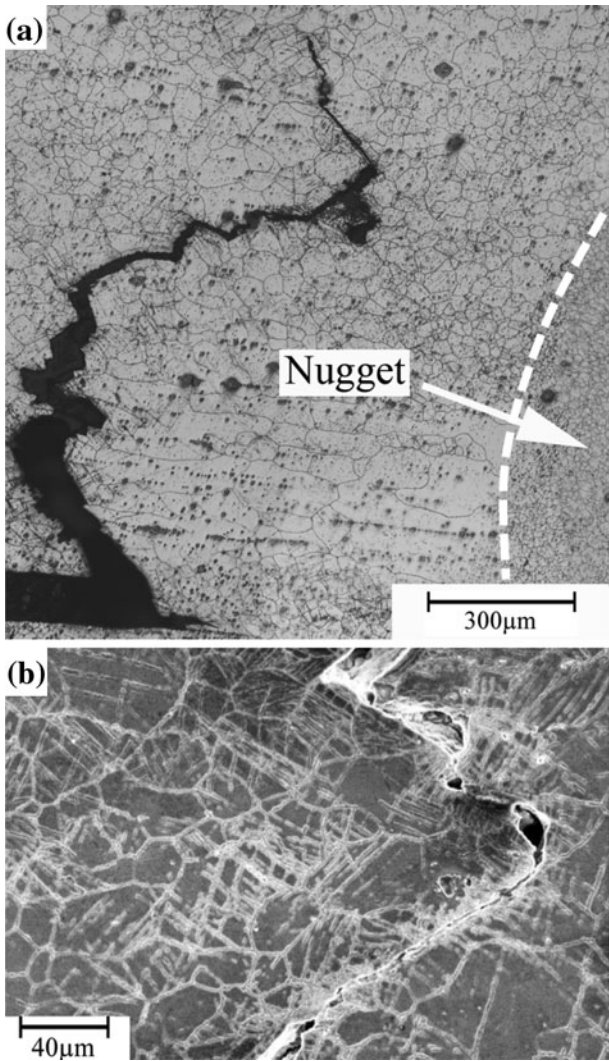
Fig. 8—(a) Typical crack propagation path in the post-weld heat-treated sample. (b) Cross-sectional microstructure near the crack region for the post-weld heat-treated sample.

For the post-weld heat-treated sample, the crack propagated on a different path as illustrated in Figure 8(a). After initiation, the crack propagated along the HAZ/base metal (BM) regions and far away from the fusion boundary. The β -Mg₁₇Al₁₂ intermetallic was not observed along the crack paths of the post-weld heat-treated sample (see Figure 8(b)). In addition, high concentrations of twinning were also observed around the crack edges, suggesting that twin deformation of α -Mg matrix was activated after the heat treatment.

significant change in fracture behavior. In the latter case, crack propagation was associated with extensive energy-consuming twinning near the crack tip (see Figure 8(b)). Thus, in the absence of GB β -Mg₁₇Al₁₂, the lattice structure resisted against crack propagation by undergoing significant twinning before fracture. The formation of twins along the crack tip was previously reported in the tensile testing of the heat-treated AZ cast alloys.^[14,29]

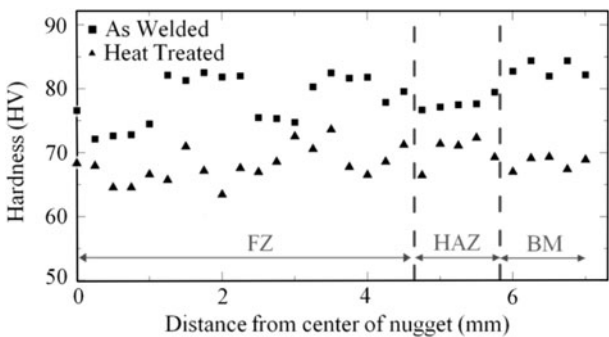
Fig. 9—Microhardness profile across the weld nugget.

Figure 9 shows the microhardness profiles across the nugget region from the base metal to the fusion zone in both the as-welded and the post-weld heat-treated conditions. A relatively uniform hardness distribution was detected in the BM, HAZ, and fusion zone (FZ). It was also observed that the hardness of FZ, HAZ, and BM decreased after the heat treatment. Grain growth and partial dissolution of the hard β - $Mg_{17}Al_{12}$ phase after the post-weld heat treatment may have caused the decrease in the hardness.

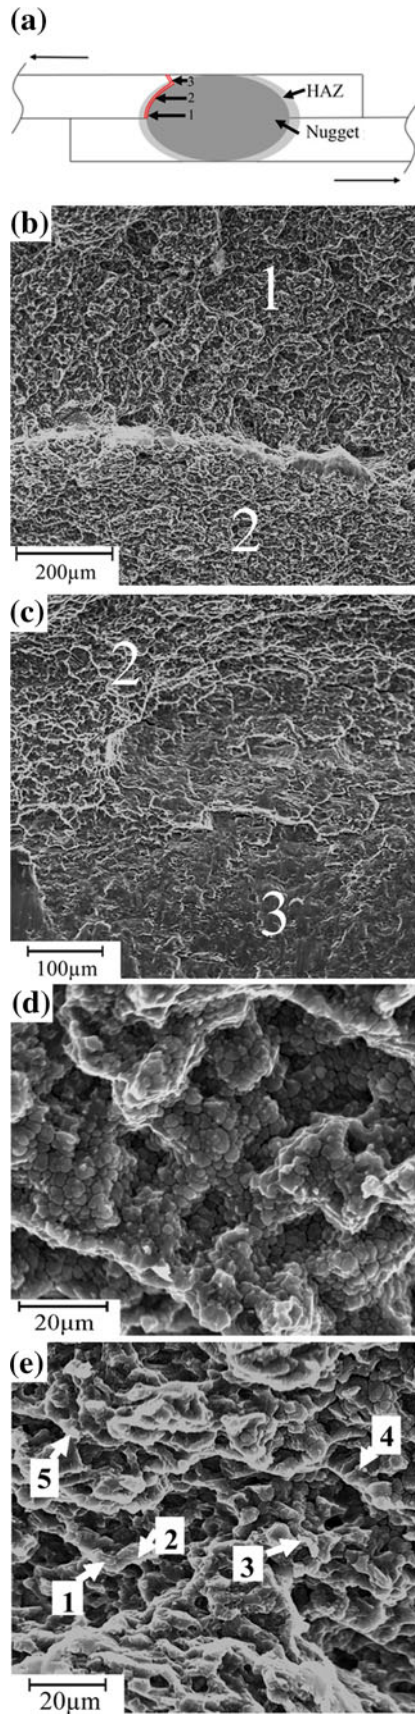
◀Fig. 10—Fracture surface of the spot weld sample in the as-welded condition: (a) Scheme of the fracture location showing three sections. (b) Fracture surface in Sects. I and II. (c) Fracture surface in Sects. II and III. (d) High-magnification image of fracture surface in Sect. I. (e) High-magnification image of fracture surface in Sect. II.

Figure 10 shows the fracture surface of a tensile specimen in the as-welded condition. Based on the fracture morphology, the fracture surface can be divided into three sections as illustrated in Figure 10(a). Figures 10(b) and (c) shows the low-magnification SEM images of these three sections while Figures 10(d) and

(e) shows high-magnification images of Sections I and II, respectively.

The Section I was located at the FZ/HAZ interface and appeared to have a dendritic structure (Figure 10(d)), which indicates that very weak joining (or no joining) occurred at the faying surface close to the notch of the nugget. Located in the HAZ, Section II appeared to exhibit cleavage-like steps as shown in low magnification image of Figure 10(b). Close analysis of the fracture surface in Section II revealed a high density of microvoids (Figure 10(e)). In Table III, the EDS analysis results, obtained from the fracture surface of Section II, indicated the presence of β -Mg₁₇Al₁₂ particles near the microvoids (P2, P3, and P5). Finally, Section III was the final fracture through the BM, which showed a shear fracture due to over loading. This fracture was associated with the presence of randomly distributed microscopic cracks (Figure 10(c)).

Aluminum has been reported as an efficient solid-solution-strengthening alloying element in α -Mg microstructure.^[9] The formation of GB β -Mg₁₇Al₁₂ in the HAZ of AZ80 depleted the surrounding regions of solute and hence softened the material.^[9] Therefore, the Al-depleted regions as shown by the white arrows in Figures 7(c) and (d) were suitable places for microvoid formation during the tensile shear test. Crack initiation in the β -Mg₁₇Al₁₂/ α -Mg interface was previously reported in different cast structures such as tensile-tested AZ91 alloy,^[11] forged homogenized AZ80 alloy^[26] and vibration-failed AZ31.^[27] The nucleation of a microscopic void/crack around second-phase particles occurred during the tensile shear testing when the internal stresses exceeded the adhesive strength of the particle/matrix interface. When this critical stress value was reached, void/crack nucleation was favored to occur. The β -Mg₁₇Al₁₂ particles were detected near the microvoids on the fracture surface of the as-welded sample shown in Figure 10(e).

The β -Mg₁₇Al₁₂ particles on the fracture surface of the as-welded sample (see Figure 10(e)) indicated that those particles were responsible for the microvoid nucleation during the tensile shear test. It was previously reported that the β -Mg₁₇Al₁₂ brittle particles nucleated microvoids and microcracks in tensile testing because of stress concentration.^[39–41] The lack of microvoids on the fracture surface of the heat-treated tensile shear samples indicated a change in the fracture mode. Fracture appearance became more similar to ductile fracture observed in the BM (Figure 11(e)). Similar observations of fracture surface made in AZ31 alloy suggested a good ductility, as well.^[42,43] The fracture morphology of the post-weld heat-treated sample in Figure 11(d) was coarser than that of the solution heat treated BM of Figure 11(e), which was consistent with the larger grain size of the heat-treated HAZ/BM microstructure compared with the as-received BM. In other words, after heat treatment, the AZ80 spot welds showed a more ductile fracture surface and the Al-rich intermetallic compounds were no longer seen on the fracture surfaces.

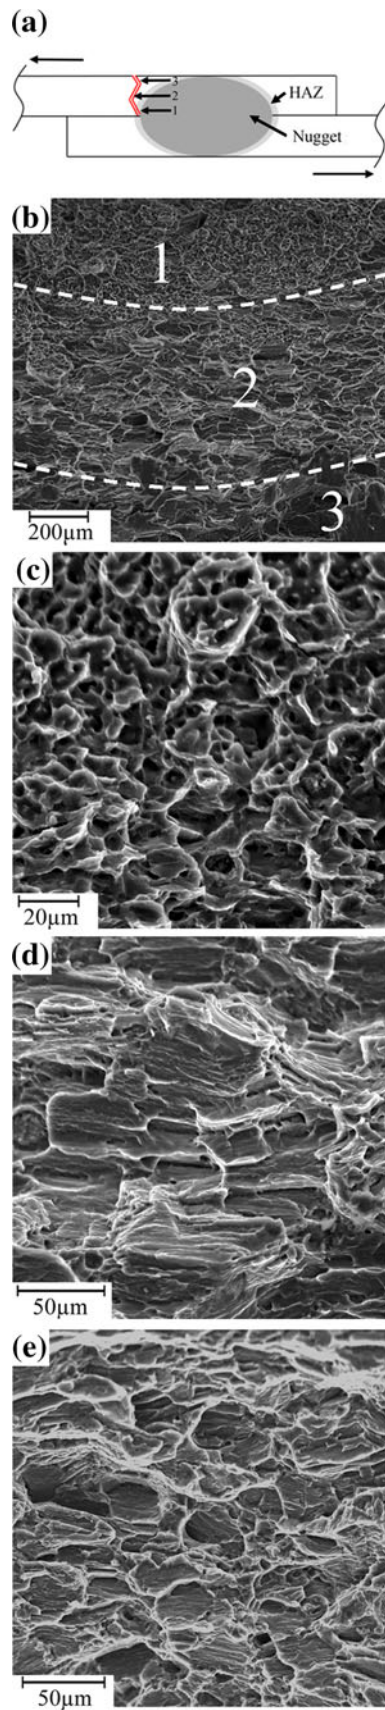
◀ Fig. 11—Fracture surface of the spot weld region in the heat-treated condition: (a) Scheme of the fracture location. (b) Fracture surface in Sects. I, II, and III. (c) High-magnification image of fracture surface in Sect. I. (d) High-magnification image of fracture surface in Sect. II. (e) Fracture surface in the AZ80 base metal in heat-treated condition.

Figure 11 illustrates the fracture surface of the post-weld heat-treated sample. The fracture morphologies were different from those of the as-welded sample. Similar to the previous case, the fracture surface of the post-weld heat-treated sample could be divided into three sections as shown in Figure 11(b), and their locations are schematically illustrated in Figure 11(a). Along the FZ/HAZ interface, the dimple-like morphology fracture surface of the Section I, shown in Figure 11(c), suggests good weld strength. This dimple-like morphology fracture surface was not observed in the Section I of the as-welded sample. The Section II was mostly related to the through-thickness fracture in the HAZ/BM region. The high-magnification SEM image in

Figure 11(d) shows a ductile fracture surface, which is similar to the fracture surface of the as-received AZ80 solution heat treated at 673 K (400 °C) for ½ hr in Figure 11(e). No evidence of Al-rich intermetallic was detected on the fracture surface of post-weld heat-

treated sample. Section III showed the same morphology as found in the as-welded sample for the Section III.
